Methods of Early Fatigue Detection

N. Rajic and K. Tsoi

**Airframes and Engines Division
Aeronautical and Maritime Research Laboratory**

DSTO-TN-0059

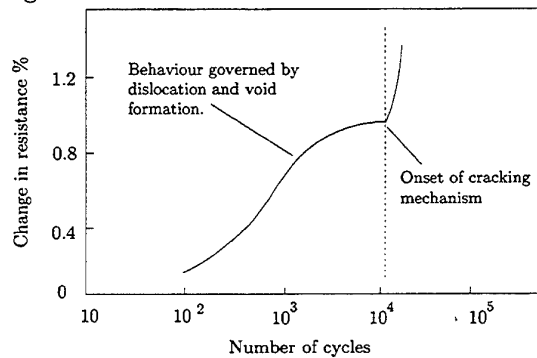
Figure 2. Typical resistance change in polycrystalline copper due to fatigue cycling.

The behaviour depicted in Fig. 2 is not typical of all metals. In Cu-Ni alloys for example, Charsley & Robins (1975) and Charsley & Shimmin (1979) found the characteristics of the resistance change to depend on the nickel content. Figure 3 shows a comparison of the approximate resistance change due to fatigue of two Cu-Ni alloys of different composition, Cu - 20% Ni and Cu - 51% Ni.

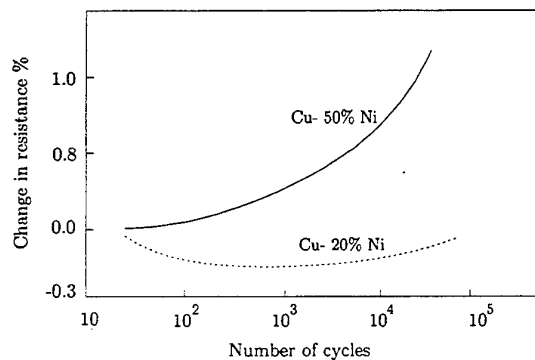
Figure 3. Typical resistance change in Cu-Ni alloy due to fatigue cycling.

A clear difference in behaviour is apparent in the early stages of fatigue; the alloy of lower nickel content initially decreases in resistance, whilst that of higher nickel content increases. Somewhat curiously, both behaviours arose via a single dominant mechanism involving the comminution of nickel clusters by mobile dislocations (Charsley & Robins (1975)). It was later reported (Robins & Charsley (1976)) that resistance changes in these alloys are dependent upon grain size, a feature not found in polycrystalline copper.

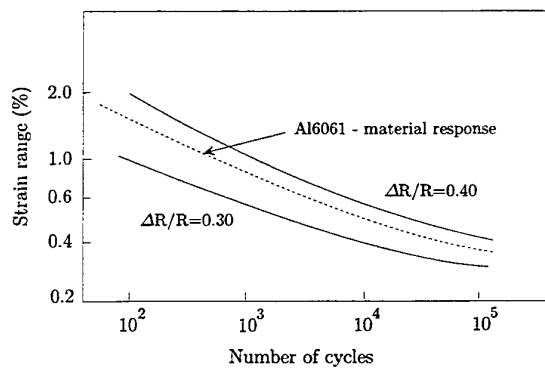
Figure 4. S-N curve for Al6061 and curves of constant $\Delta R/R$ for polymer fatigue gauge. ΔR is the change in resistance from an initial value of R

subjected to constant-amplitude fatigue cycling. They found that the change in resistance of the polymer gauge was strongly correlated with the fatigue failure of the structure for certain metals. The correlation was expressed in terms of the similarity between the S-N curve for the metal and the S-N curve for the polymer gauge at a constant $\Delta R/R$. This is depicted in Fig. 4 in which an S-N curve for Al6061 is seen to be approximately parallel to curves of constant $\Delta R/R$ for the polymer fatigue gauge. The curve for $\Delta R/R = 0.37$, not shown in the figure, was reported by the authors to coincide with the Al6061 S-N curve.

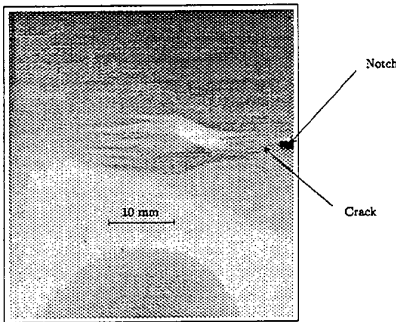
Figure 5a. Plastic zone.

The plastic deformation of a highly polished specimen can often lead to a noticeable surface roughening due to the impingement of dislocations on the specimen surface. Shown in Fig. 5a is a polished mild-steel specimen containing a fatigue crack, and adjacent to and extending from the crack, a region shaped like a hand which is effectively the zone of monotonic plastic deformation caused by the application to the specimen of a tensile load normal to the crack propagation direction. In the case depicted in this figure (see Rajic 1995), the observed surface roughening was exploited to identify the extent of a plastically deformed region. However, the phenomenon has also been proposed as a useful means of fatigue characterisation. In a recent paper by Nagase *et al* (1995), thin aluminium foils were bonded to a fatigue-loaded structure with the view of correlating the evolution of surface roughening in the foil with the fatigue history of the specimen. Under constant stress-amplitude loading, the relationship between the measure of surface roughness, Ra , stress amplitude, σ , and number of loading cycles, N , was expressed as,

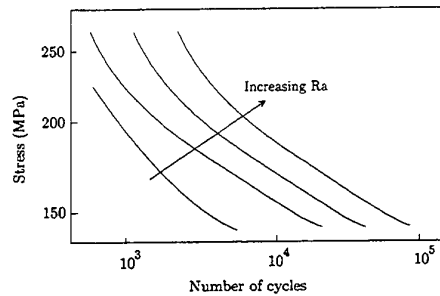
Figure 5b. S-N curves for constant Ra 's.

where Ra_n is the roughness measured after $\sum N_i$ cycles. This expression was applied to experimental data with mixed results. In tests involving only a few stress-amplitude variations, the expression failed to describe the gauge behaviour well because of its disregard of the ordering of these variations (i.e. high-low & low-high). However, with increasing numbers of stress-amplitude variations, the effect of ordering diminishes and the expression under these conditions was found to provide a satisfactory description of the gauge behaviour.

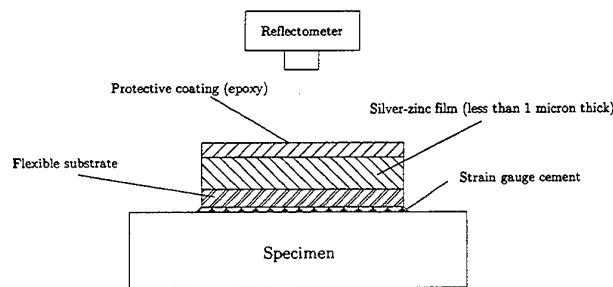
Figure 6. Colour Displaying Fatigue Sensor, from Scott (1977).

Scott (1977) describes a fatigue sensor that exploits the tendency of silver-zinc alloy to change colour in response to fatigue loading. The colour change is reported to occur due to the silver-zinc film undergoing a martensitic phase transformation in response to cold work induced by cyclic loading. Since it exploits colour variations, this gauge has a unique advantage among fatigue sensors in that it should enable one to gain a qualitative indication of the fatigue state of the underlying structure by simple visual inspection. A more quantitative measure of the colour change, which is stated as being from pink to silver, can be obtained with a spectrometer. The sensor is shown schematically in Fig. 6.

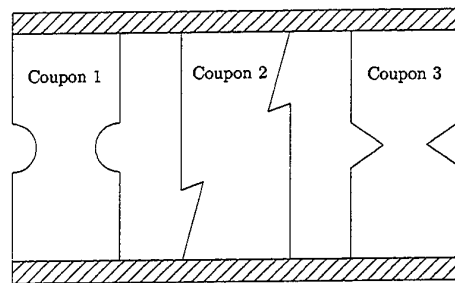
Figure 7. Tensiodyne fatigue fuse.

A modern adaptation of DeForest's idea can be found in the *Fatigue Fuse* device marketed by Tensiodyne Scientific Corporation. The fuse is made from a thin sheet of the same material as that of the structure being monitored, and comprises a number of coupons, each providing a stress concentration of different but known severity. When subjected to the same strain history as that imposed on the member being monitored, the coupons progressively fail prior to the member, thereby giving a warning of the structure's impending failure. By having several coupons in the fuse, each with a different stress concentration,

it is possible to estimate the residual life of the structure at several stages in its life. Figure 7 shows a basic outline of the fuse. The coupons presented in this figure are derived from patent held by Tensiodyne (1986) and represent only a few of the many shapes available. Note that only the hatched portion of the fuse is bonded to the structure.

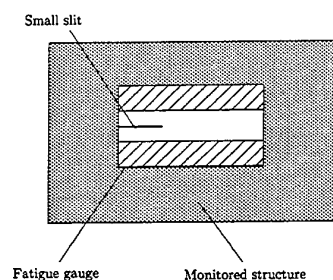
Figure 8. Fatigue gauge from Smith (1976).

Smith (1976) developed and patented a device similar to the *Fatigue Fuse*, which, instead of having a notch, has a small slit, see Fig. 8. The principle is the same, that is the accumulation of damage in the device, in this case indicated by progressive crack growth, is used to infer information about the fatigue state of the structure. Geissler & Gallagher (1983) describe an investigation carried out for the USAF into the application of this type of gauge to aircraft fatigue-damage tracking. They concluded that the proposed

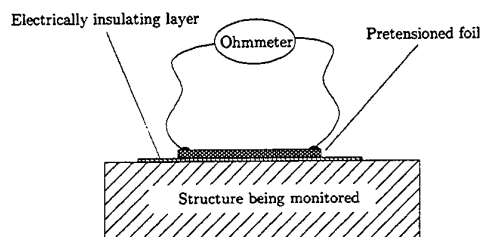
Figure 9. Mean-stress Gauge.

It is well known that the superposition of a tensile mean stress on a fluctuating load has a detrimental effect on fatigue life. Furthermore, it is possible to estimate the reduction in life from S-N curves which include R-ratio (mean stress) variations. Given this, it should in theory be possible to attach to a structure a pretensioned foil made of the same material, such that it breaks at a predetermined (from S-N curves) number of fatigue cycles before the structure, and thereby gives warning of the structure's impending failure. The fatigue state of the foil could be tracked by continuously measuring its electrical resistance; failure would obviously be indicated by a large increase in its resistance. This is however a rather crude application of the concept. One will recall from earlier discussions that the residual resistivity of a metal is generally dependent upon its fatigue state and that changes in this resistivity occur well before the formation of a macrocrack. Hence, if the resistance measurements were to be made with sufficient precision to detect changes in the residual resistivity, it should be possible to know the fatigue state of the foil (and therefore the structure) continuously and from an early stage in its life. The basic elements of the gauge are shown in Fig. 9.

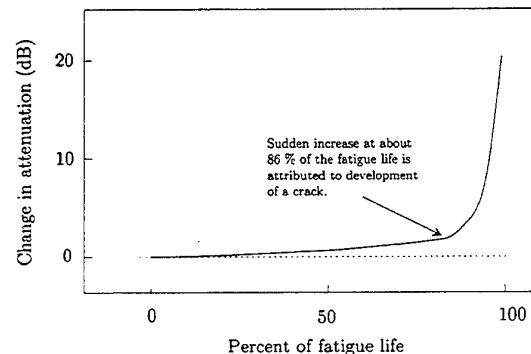
Figure 10. Schematic of an ultrasonic attenuation response for Al7075-T6 alloy

A representative plot of ultrasonic attenuation as a function of the number of loading cycles is shown in Fig. 10, which depicts a similar behaviour to that in Mignogna *et al* (1980), and relates to a fatigue test on 7075-T6 aluminium alloy. Although the attenuation is seen in this figure to increase in the early stages of fatigue, this behaviour is not observed in all cases. Depending on the material composition, loading conditions and temperature, the attenuation may actually decrease (Joshi & Green (1975)). For a detailed treatise on the relationship between dislocations and ultrasonic attenuation, the reader is referred to Nabarro (1987).
